STATE OF CALIFORNIA
DEPARTMENT OF PUBLIC WORKS
DIVISION OF HIGHWAYS

CALIFORNIA'S EXPERIENCE
WITH CONCRETE PAVEMENTS

By
F. N. Hveem
Materials and Research Engineer

April 1961

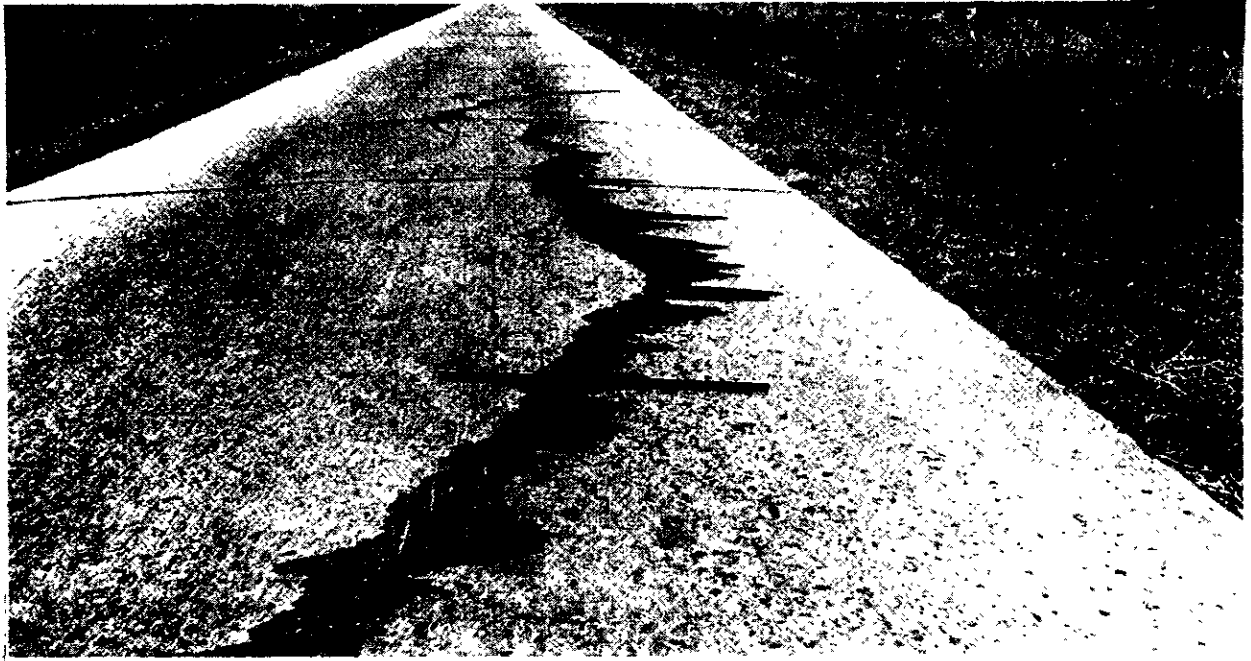
Fig. 1

15-ft Concrete pavement showing wide longitudinal crack caused by expansive soils.

The standard design for concrete pavements was a continuously poured slab 4-in. in thickness and 15-ft. wide which often developed cracks over the heavy clay soils, Fig. 1. With increased traffic, criticism of these narrow pavements became rather marked and, in fact, it was one of the factors in the political campaign for Governor in 1924. In 1923, the standard was increased to a 5-in. depth and the width to 18-ft. However, with the election of a new Governor and the appointment of a new State Highway Engineer in 1924, the standard width of pavement was increased to 20-ft. Because of rather extensive failures in the original relatively thin concrete pavements over poor soils and where irrigation had saturated the terrain the new Engineer decided that it was necessary to construct better bases and foundations for the concrete pavements and therefore State Highway Engineer R. M. Morton embarked on a broad policy of first constructing gravel roads before attempting a more permanent type of surface. About 1929, California began to control the compaction of embankments and subgrade soils and engineers were led to believe that if soils were thoroughly and properly compacted there was no need for improved base courses beneath the concrete pavements. It was nearly 20 years later before it was realized that concrete pavements should rest upon something other than silt or clay soils.

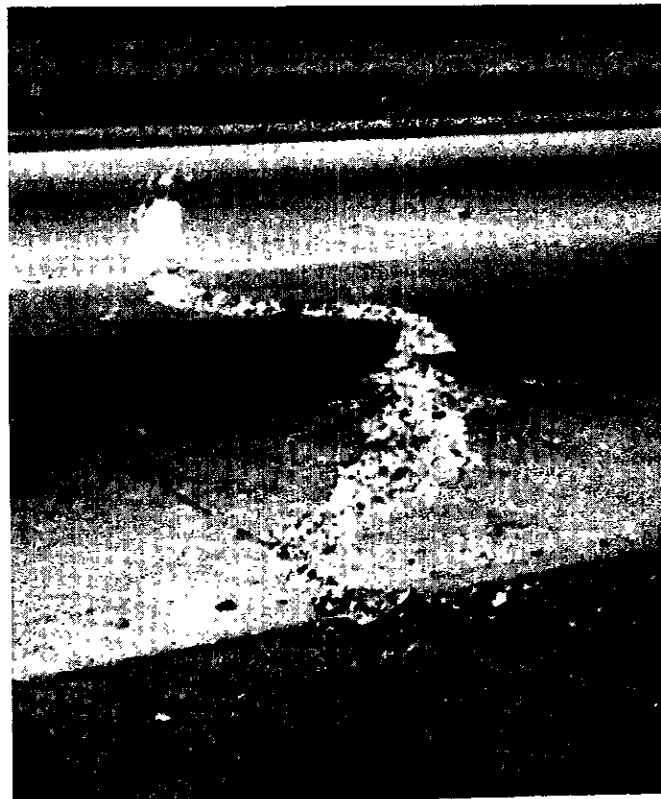
Fig. 2

A "blowup" due to expansion of a concrete pavement. 8" slab did not buckle.

Up to about 1923, concrete pavements were constructed without provision for expansion or contraction and occasionally these thin pavement slabs would buckle or "blow up" due to

expansion in hot weather, Fig. 2. Blowups of concrete pavements were experienced in most states although the tendency was much more marked with certain types of aggregates than with others. Reports from the middlewestern states, such as Kansas, indicated that the most frequent breakup of concrete pavements occurred in sections constructed with flint aggregates and these blowups were most noticeable following a thunderstorm when the wet pavement became heated under the direct rays of the sun. Engineers of the U.S. Bureau of Public Roads recommended that provision should be made for expansion and in 1924 California began to provide expansion space by leaving a timber header in the pavement when the work was stopped at noon and at the end of the day. Later, the wooden strip was removed and the space filled with a mixture of asphalt and sawdust.

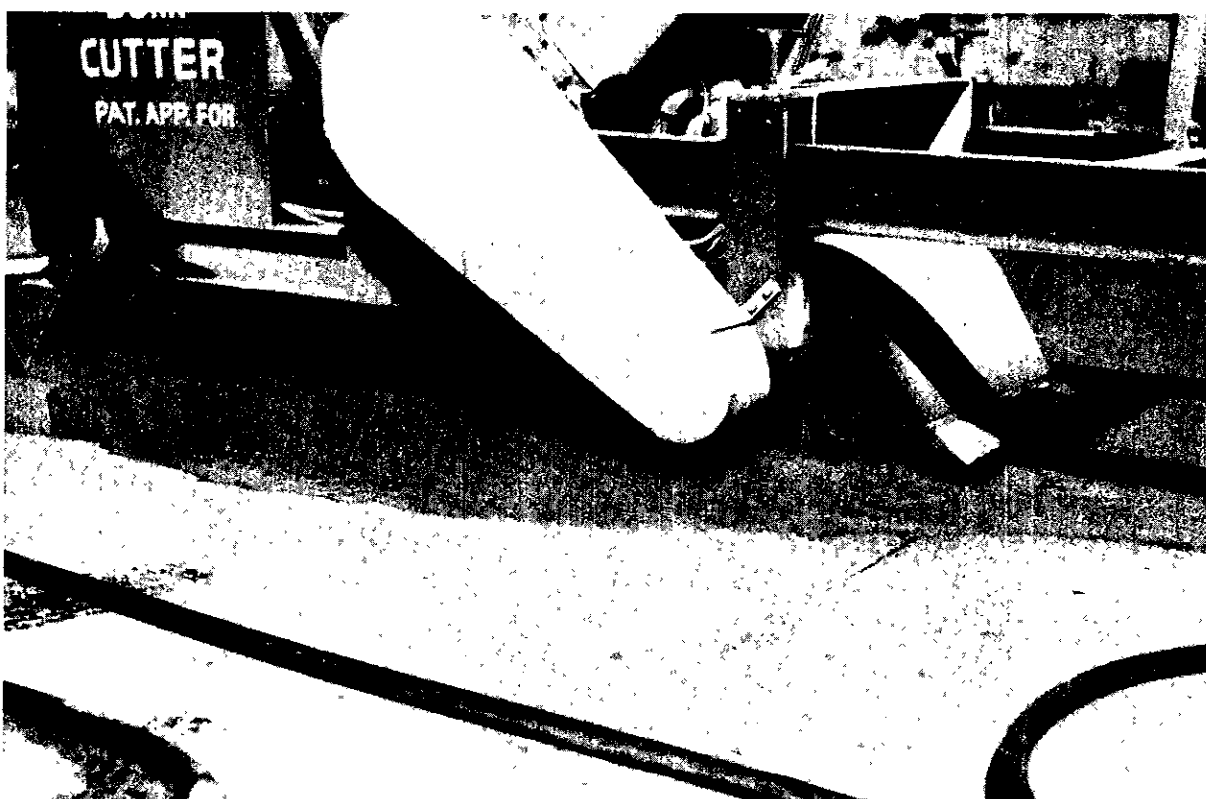
Fig. 17
Pavement grinder.

For the past year, California specifications for concrete pavements have carried a requirement that the surface smoothness or riding qualities will be measured by the Profilograph and wherever the pavement exceeds the specified tolerances the surface high spots must be ground down. Figure 16 shows a profilogram of several pavements; (a) is a very smooth riding surface, (b) represents the limit of tolerance now set forth in our specifications, (c) is a rough riding pavement. Figure 17 is a photograph of the type of machine used to grind down the high

spots on the pavement. This machine is similar to those used for sawing joints in the concrete except that a series of cutting blades are used. Figure 18 is a close-up view of the pavement surface after the grinding. Care must be used in selecting the type of grinding operation. On one project a contractor elected to use a type of device designed for polishing concrete pavement to produce a terrazzo like finish. The resulting pavement was so smooth that a dangerous skid hazard was presented. The type of surface left by the series of narrow bladed cutting discs has a definite non-skid pattern. In fact, this device has been used to correct pavement surfaces that were found to be dangerously smooth as a result of improper finishing operations. Our new specifications will require that all concrete pavements be finished in a fashion, either with a burlap drag or other means, to produce a surface having a coefficient of friction not less than 0.25.
